## **İzmir Kent Örneğinde Bazı Kentsel Sitlerdeki Antropojenik Baskıların İrdelenmesi Üzerinde Bir Araştırma<sup>1</sup>**

A Research About Anthropogenic Pressures on Some Urban  
Sites in the Example of Izmir City

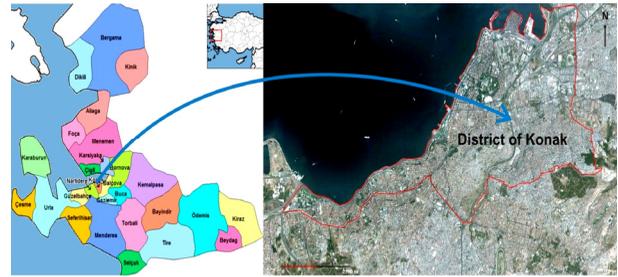
Figure 1. Location of study area (Anonymous, 2007; Google Earth Image, 2010)

The research areas are Kemeraltı and Konak Square and its vicinity (latitudes 38° 25' 25" N – 38° 24' 56" N and longitudes 27° 7' 18" E – 27° 8' 10" E) (Figure 1).

Kemeraltı (226112.77m<sup>2</sup>) which is an urban site and Konak Square and its vicinity (267992.50 m<sup>2</sup>) which is a historical site are chosen to exemplify two different protected area types in İzmir. Also their location in city center and their importance for city image since the beginning of urban development are the other reasons to be chosen as research areas.

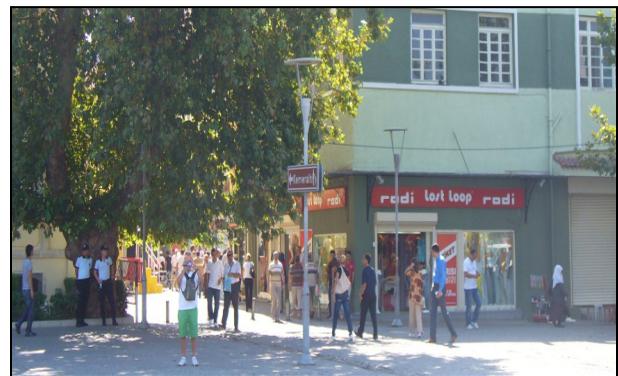
Figure 2. Entrance to Kemeraltı from Konak Square

Kemeraltı is a historical commercial zone which encompasses a broad area stretching from the Mezarlıkbaşı neighborhood to Konak Square. In Figure 2 the present day view of the entrance to Kemeraltı from Konak Square is seen. Anafartalar Street, which today constitutes the main street of the bazaar in which it is situated, runs in a wide curve. This curve results from the fact that the street ran around the inner harbor which used to be here in past centuries. As the harbour over time began to fill up towards its mouth, new settlement and trading areas were opened up and these were used for new buildings (T.C. İzmir Valiliği, 2006).

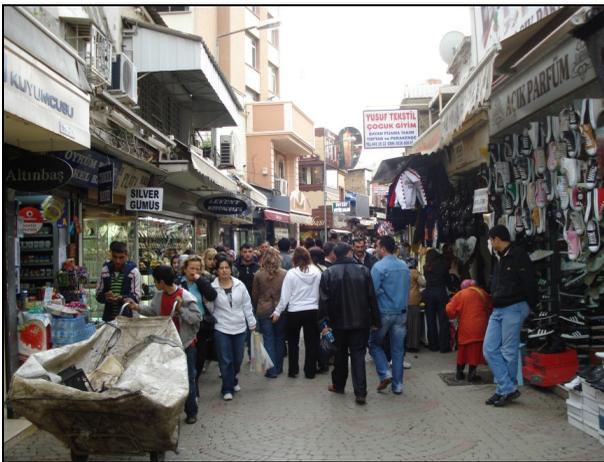
Figure 3. General view of Kemeraltı

In its first years this bazaar, with its in parts vaulted, tile-roofed, side streets and its 'arasta's where craftsmen of the same branch were grouped together, had the appearance of a covered bazaar. As it used to be in the past, today also Kemeraltı bazaar is İzmir's most important traditional shopping center (Figure 3). Even though the number of mystical vaulted and domed shops of the past has dwindled, with its modern business centers, stores, cinemas and cafeterias its streets have the appearance of a location which is vibrant at every hour of the day and where all types of shopping can be done (T.C. İzmir Valiliği, 2006).

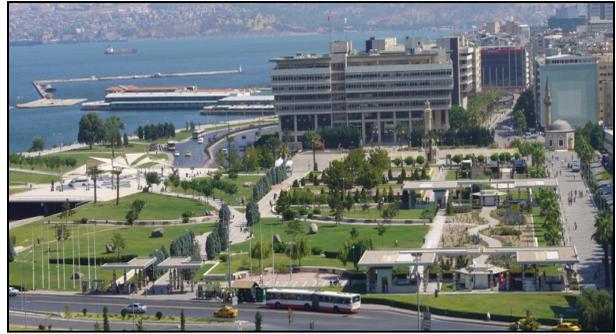
Figure 4. General view of Konak Square and its vicinity

The reverberation of the Ottoman Empire's modernization process, which began in the XVIII th century, on its cities started to be felt in the early part of the XIX th century and this transformation formed the basis for the emergence of a new urban configuration in İzmir's physical structure. For this reason, as in the empire's other cities, it is not possible for there to have been a public centre in İzmir previous to the XIX th century. Thus, the emergence of such a centre became possible as the state entered upon the route towards becoming a modern monarchy (Yetkin and Yılmaz, 2006). In Figure 4, some areas which lie within the boundary of the borough of Konak and which are of importance particularly from perspective of change have been marked. The Yalı (Konak) Mosque, Clock Tower and Katipoğlu Mansion are some of the historical works still present in Konak Square today.

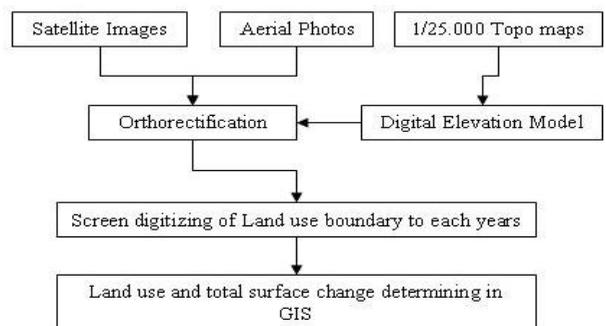
Figure 5. Flow chart of method

The research method is based on the geographical correction and digitalization of topographic maps, aerial photos and satellite images by using Geomedia, Image Analyst and PCI Geomatics softwares, and the determination of anthropogenic impacts on the protected sites arising as a result of the changes undergone (Figure 5).

In order to determine to a high level of accuracy of the boundaries of the protected sites, which are the main material of the study, high-resolution images from the IKONOS and KVR-1000 satellite and aerial photos were used for orthorectification of these images, a digital elevation model (DEM) on a 1/25.000 scale formed from digital contours was used. This model was formed using the PCI Geomatics software. In addition, field work was used as support to increase the accuracy of the orthorectification. In the fieldwork, ground control points collect by using Trimble GeoExplorer 2005 GPS. In order to form a digital base map of the study area, all data such as roads, water courses and settlement areas was converted to digital form using GeoMedia software from 1/5.000 land registry maps and 1/25.000 topographical maps.

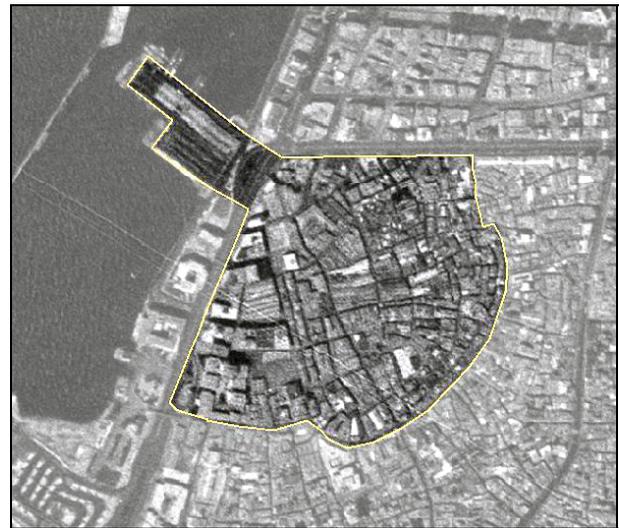
Figure 6. A KVR-1000 satellite image of Kemeraltı and its vicinity from the year 1987

In Figure 6, a KVR-1000 satellite image pertaining to years 1987; in Figure 7, an aerial photos pertaining to the year 1997 and in Figure 8, an IKONOS image from the year 2005 of Kemeraltı and its vicinity are to

In Kemeraltı, no change was found in the total surface area between the years 1987 – 1997 – 2005 caused by anthropogenic impacts (Table 2). Total surface area of Kemeraltı was found to be 226112.77 m<sup>2</sup> and there was not any green space in this protected area. The area taken up by buildings was determined as 195741.75 m<sup>2</sup> (86.57%) in 2005.

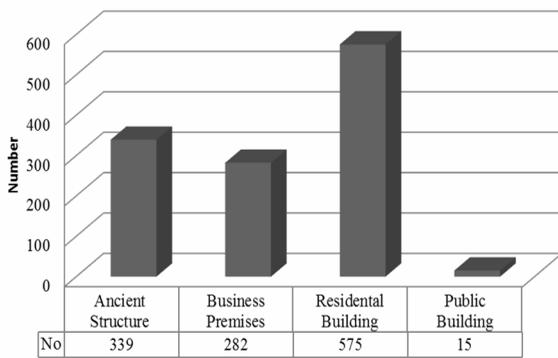
Figure 9. Building Types at Kemeraltı Historical Centre

be seen. On examining the types of structures in this area, of a total 1211 buildings 28% (339) were found to be ancient structures, 23% (282) business premises, 48% (575) residential buildings and 1% (15) public buildings (Figure 9). While no change was seen in Kemeraltı between the years 1987-2005, housing was observed to exert the greatest structural area pressure. Meanwhile, the structures constituting ancient edifices come second. It has been seen that the preservation of Kemeraltı's historical fabric will only be possible with the restoration of these works and with the landscaping of the surrounding area in harmony with the historical fabric.

Also observations relating to this study have shown the same consequences. It couldn't find any changes in the Kemeralti historical center, according to results of change detection related anthropogenic pressure between years of 1987-2005. 86.6% of the total area is building area which is shown that the area is lack and deficient of green areas. It is observed in the study area related building types 28% of them are ancient structure, 23% are commercial, while 48% are residential; naturally residential building types have the biggest pressure on site.

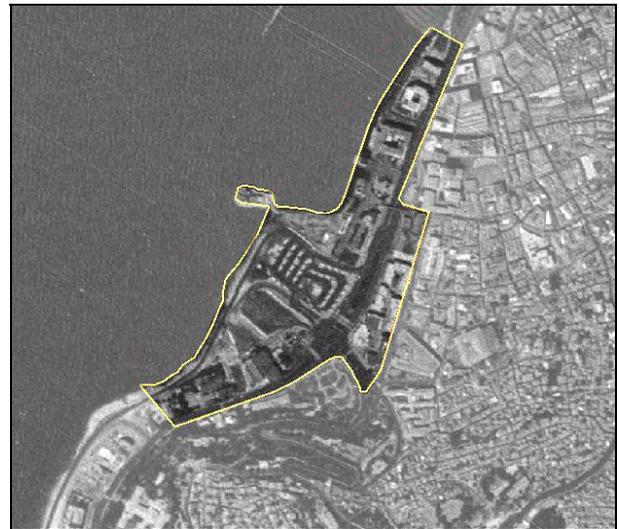
Figure 10. A KVR-1000 satellite image of Konak Square and its Vicinity from the year 1987

In Konak Square and its vicinity the historical site boundary has expanded in area by approximately 41% over the years. On looking at the aerial photo, KVR-1000 satellite image and IKONOS image it can be said that the greatest factor in this expansion is the filling-in of the sea and that there has been no change in the structural areas. However, the square has constantly been used and landscaped in different ways over the years. In Figure 10, a KVR-1000 satellite image, in figure 11, an aerial photo of Konak Square and its vicinity and in Figure 12, an IKONOS image of the same area are given.

In Konak Square and its vicinity, which lies within protected historical site boundaries, the structural area was found to have expanded as a result of work carried out to fill in areas towards the sea. The increase seen in this area between the years 1987 - 2005 was determined as being 78654.60 m<sup>2</sup> (Table 3).

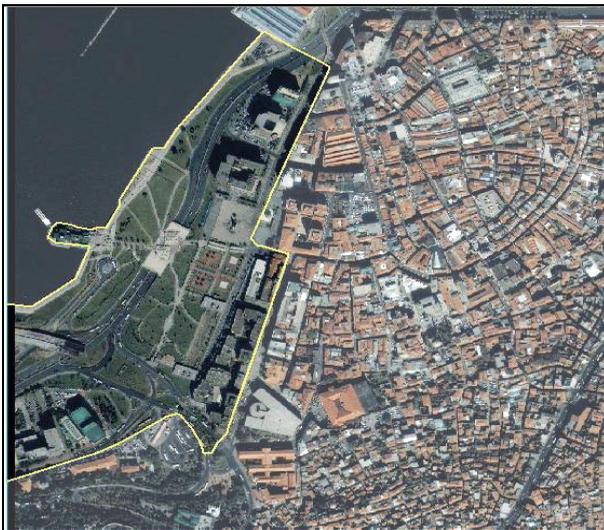
The boundary of research area  
 Figure 12. A IKONOS image of Konak Square and its vicinity from the year 2005

On examining the usage types in the protected historical sites in Konak Square and its vicinity, which have a surface area for 76797.18 m<sup>2</sup> (28.66%) were open green spaces and 38,799.20 m<sup>2</sup> (14.48%) was taken up by buildings in 2005.

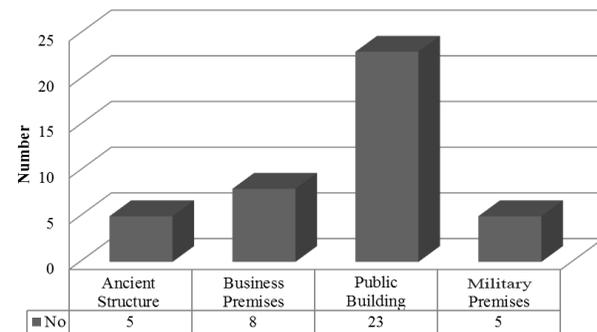
Figure 13. Building Types at Konak Square and its vicinity

On examining the building types found within the boundaries of the protected historical sites, 12% (5) were found to be ancient structure, 20% (8) business premises, 56% (23) public buildings, and 12% (5) military premises (Figure 13).

According to results for Konak square and its vicinity shows that in 1987-2005, the most significant increasing of the area is because of backfilling works to the seawards to get new constructional lands. Meanwhile the total area was 18934 m<sup>2</sup> in 1987 and between 1997-2005 it's reached to 29799 m<sup>2</sup>. 29% of the area determined as open spaces and green areas. According to determination about building types on the historical sites; public buildings have the highest degree with 56%, commercial buildings take the second heights degree with 20% and 3rd and 4th largest buildings types are with both 12% of the area ancient works and military premises.
